Manhole Inspection Summary

Manhole # S29U1_003MH

Insp Date: **5/1/08 10:36 AM**

Location Address: **600 W. Patapsco Ave.**

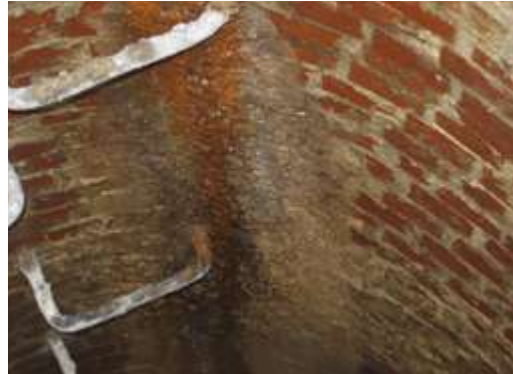
Defect 2

Infiltration: ☐ None ☐ Joint ☐ Cracks ☐ Mortar ☐ Roots ☒ Wall

Infiltration

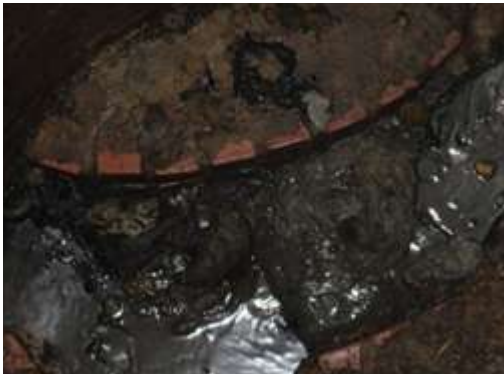
Defect 1

Condition: ☐ Sound ☐ Cracked ☐ Root Intrusion ☐ Deteriorated ☐ Leaks ☒ Debris

Waste in channel

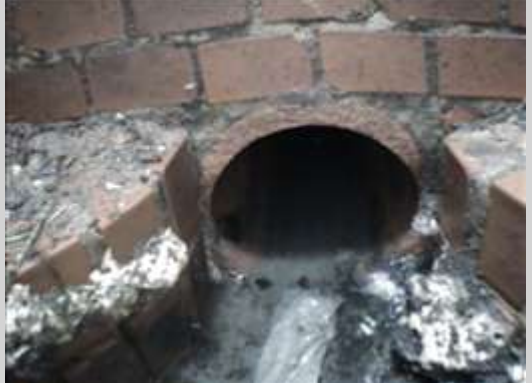
12 O'Clock Outflow

8 in. Circular Gravity Sewer
Pipe Out @ 12 O'Clock

Pipe Height: **8.4** (in.) Rod and Bar (Angled)
Pipe Material: **Clay** ☐ Pipe Lined
Invert Depth: **10.85** (ft.) Flow Characteristics: **Fast**
Deposits: ☒ None ☐ Mud ☐ Sludge ☐ Debris ☐ Grease
Silt Depth: (in.) Deposits Extent:
Infiltration: **None** Pipe Seal Cond: **Sound**

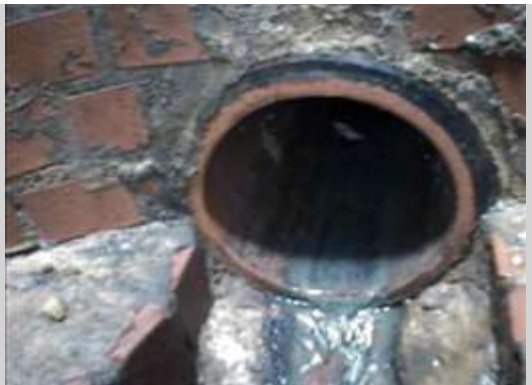
3 O'Clock Inflow

8 in. Circular Gravity Sewer
Pipe In @ 3 O'Clock

Pipe Height: **8.4** (in.) Rod and Bar (Angled)
Pipe Material: **Clay** ☐ Pipe Lined
Invert Depth: **10.40** (ft.) Flow Characteristics: **Fast**
Deposits: ☒ None ☐ Mud ☐ Sludge ☐ Debris ☐ Grease
Silt Depth: (in.) Deposits Extent:
Infiltration: **None** Pipe Seal Cond: **Sound**

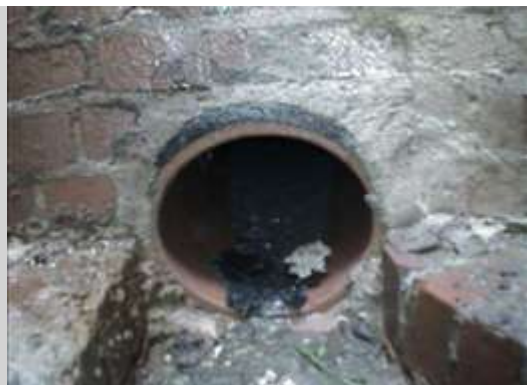
9 O'Clock Inflow

6 in. Circular Service Sewer
Pipe In @ 9 O'Clock

Pipe Height: **8.4** (in.) Rod and Bar (Angled)

Pipe Material: **Clay** ☐ Pipe Lined

Invert Depth: **10.43** (ft.) Flow Characteristics: **None**

Deposits: ☒ None ☐ Mud ☐ Sludge ☐ Debris ☐ Grease

Infiltration: **None**

Pipe Seal Cond: **Sound**
